**LOCATION** Mingo Junction, OH

**COMPLETE THE CIRCUIT**

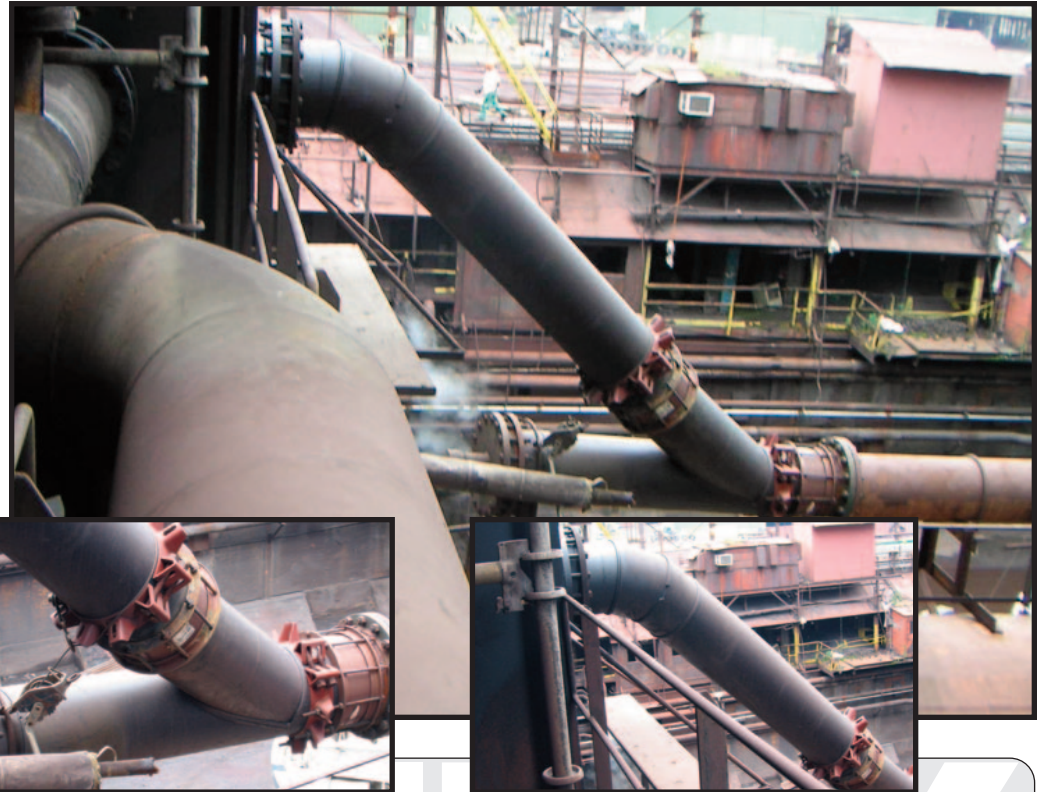
- Contaminated water from the "BOF" cooling system is recycled from the treatment plant to the furnace in a complete circuit requiring various fittings and a substantial amount of pipe.

- Lee Supply field technicians measured and fabricated an 18" HDPE lateral, other fittings and pipe to specification.

- New material reduces the need for frequent repair and replacement
- Withstands corrosive slurry
